Manhole Inspection Summary

Manhole # S25C__029MH

Location Address: **1122 FRANKLIN ST**

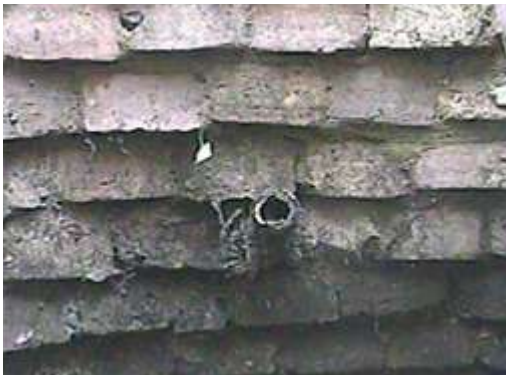
POSSIBLE ILLICIT CONNECTION

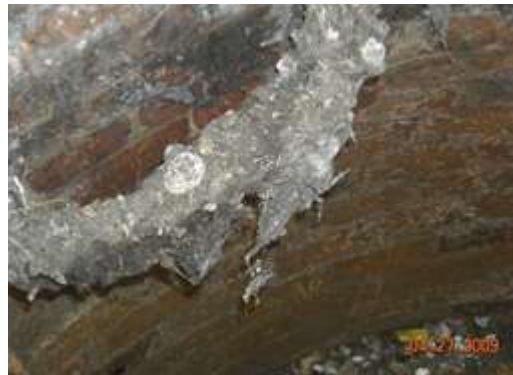
Defect 2

☒ **Evidence Of Surcharge** Depth: **2.5** (ft.) ☐ Active Surcharge Present

EVIDENCE OF SURCHARGE ON
BOTTOM STEP

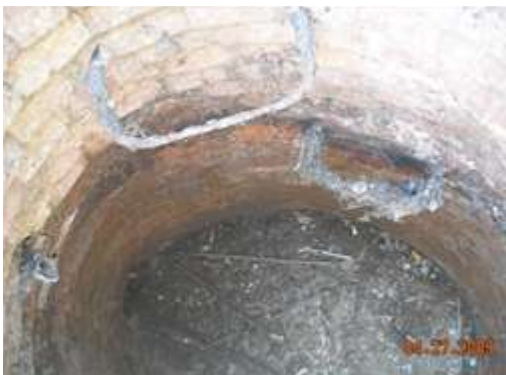
Defect 1

Count: **2** Missing: **1** ☒ **Corroded**

CORRODED STEPS

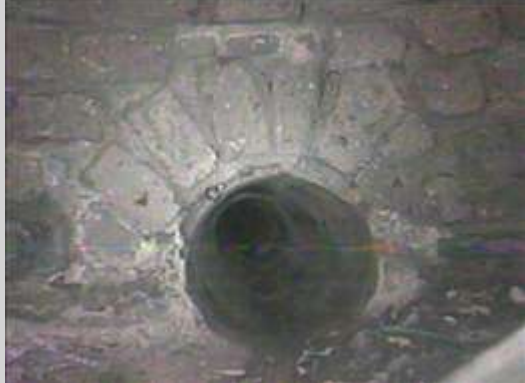
12 O'Clock Outflow

8 in. Circular Gravity Sewer
Pipe Out @ 12 O'Clock

Pipe Material: **Clay** ☐ Pipe Lined

Invert Depth: **6.25** (ft.) Flow Characteristics: **None**

Infiltration: **None** Pipe Seal Cond: **Sound**
